Ankerwycke Priory,  
Wraysbury, Berkshire.

An archaeological evaluation  
for Berkshire County Council, Department  
of Highways and Planning

Report 93/1

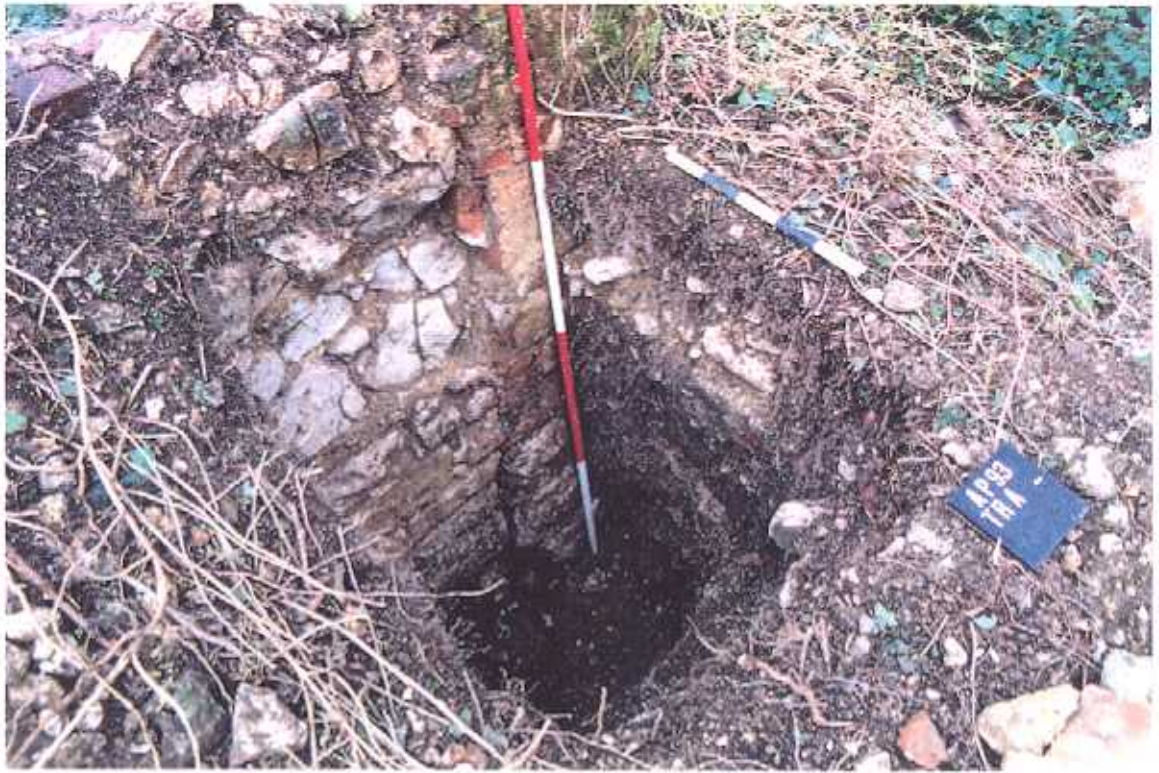
This trench was 3.1m long and was located at right angles across a mound located on the RCHME plan of the site (Fig. 3). Unexpected depths of deposits were encountered. It showed that the mound was a wall upstanding for at least 2 m. and was 1.2 m. wide (Figs. 4 and 5) (Plate 1). As elsewhere on the site, the wall was built of chalk blocks, with well-faced deposits for 1.5 m of height. At the base of the trench on the eastern side, less well-faced stone work jutting out slightly from the wall was probably the top of the foundations. The end of the wall was finished with a brick built pier which was butted onto the part constructed of chalk.

The trench on the western side of the wall showed that the original wall had been refaced by brick, probably in the 19th century. The foundations were not reached on this side but the refaced brickwork presumably had been dug down to this level.

Plate 1 Ankerwyke Priory 1993. Detail of Trench A (eastern side of wall).

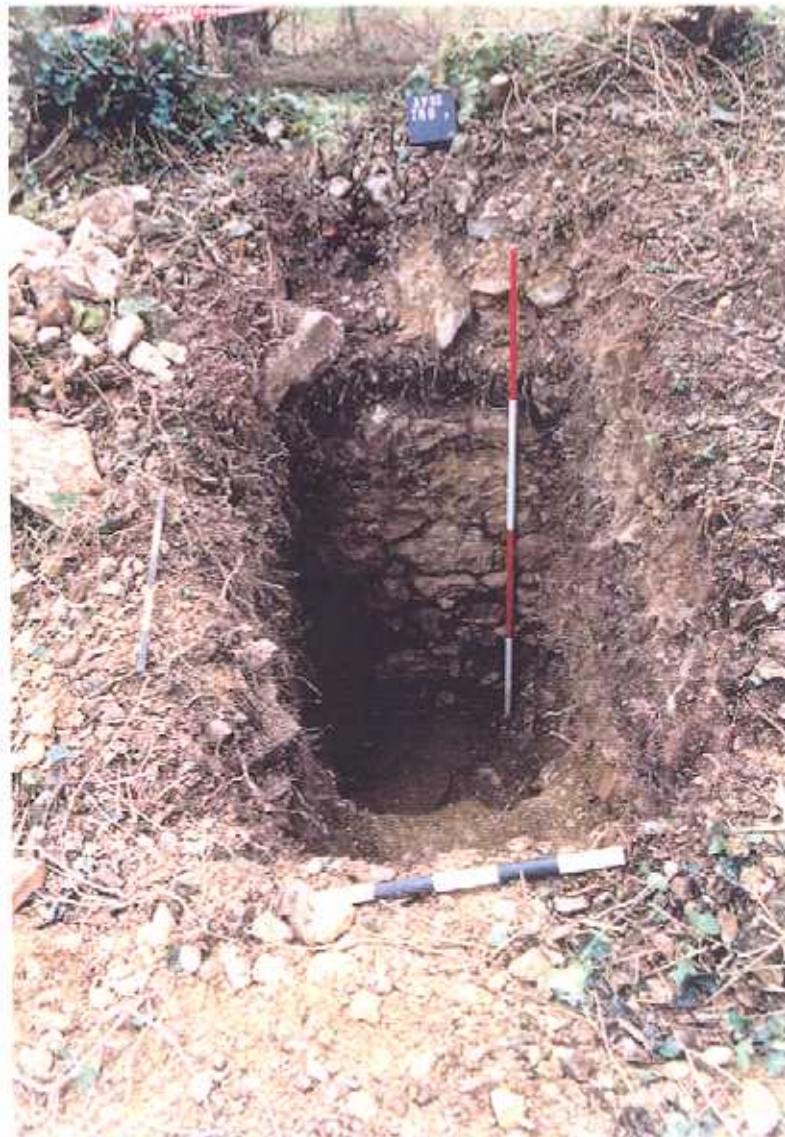
At least 2 m. of wall was upstanding with well-faced work existing for 1.5 m. The base of the trench comprised an in-situ tiled floor. Some of the tiles were missing (Plate 2). No further excavation took place below this level and the depth of the foundations was not determined.

Plate 2 Ankerwyke Priory 1993. Trench B looking south showing tiled floor.
