**New parish rooms, St Andrew's Church,
Sonning, Berkshire**

Archaeological Watching Brief

**An Archaeological Watching Brief
For Sonning Parochial Church Council**

Site Code ACS 13/99

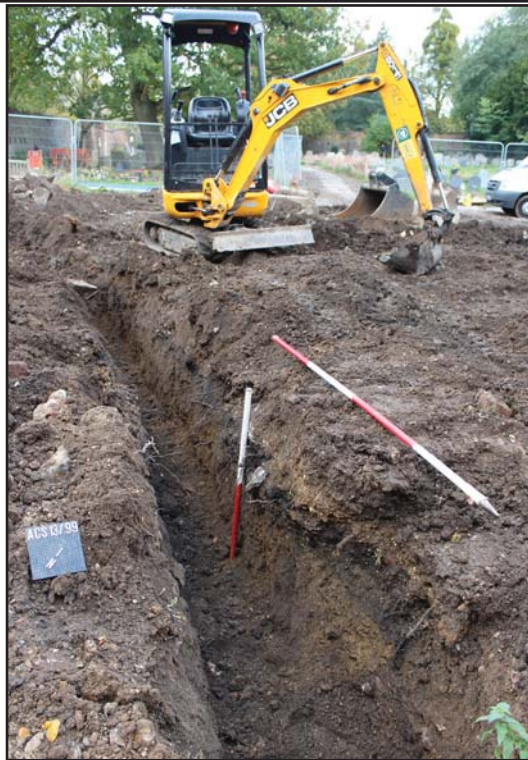
Trench 1 was 15m long and 0.35m wide with a maximum depth of 0.70m. The stratigraphy (Fig. 4) uncovered consisted of 0.20m of topsoil and 0.25m of dark greyish brown sandy silt (52) with frequent gravel and occasional brick and tile fragments, overlying mid orange brown sandy silt (53) with gravel and occasional brick and tile fragments. The trench did not penetrate to the natural geology. At the north end of this trench, a 16m length of the trench for a previous water pipe was uncovered. This area was already disturbed by the excavation of the previous trench.

One possible pit was uncovered during the excavation of this trench and was hand cleaned and investigated, showing this to be filled with mid brown silt and gravel inclusions and modern brick and tile fragments.

Plate 1. Trench 1, looking South West, Scales: 2m and 1m.

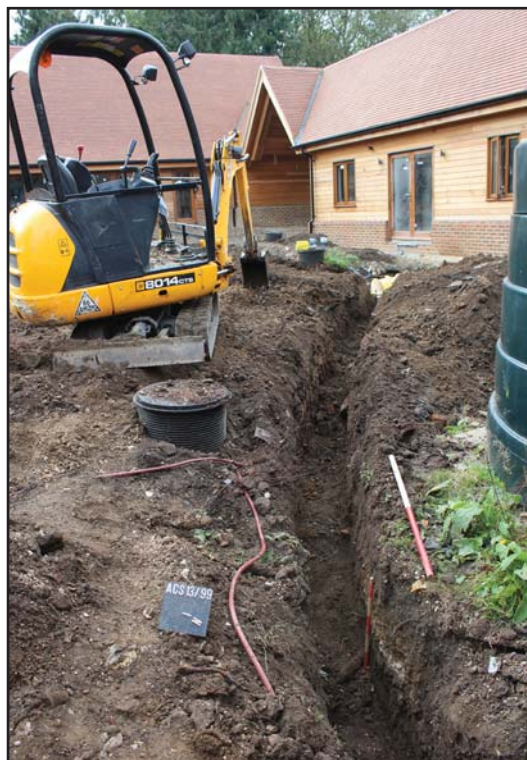
Trench 2 was 24m long and 0.35m wide with a maximum depth of 0.70m. The stratigraphy observed consisted of a made ground sequence, formed by 0.30m of dark brown sandy silt with gravels and brick and tile fragments, 0.20m of mid yellowish brown sandy silt with gravels and chalk inclusions, overlying mid reddish brown sandy silt with occasional brick and tile fragments. This trench continued beyond the northern wall of the site with similar stratigraphy. The natural geology was not reached and no archaeological finds or features were present.

Plate 2. Trench 2, looking West, Scales: 1m and 0.50m.
