**23 High Street, Haddenham,
Buckinghamshire**

**An Archaeological Evaluation
for Rectory Homes**

Thames Valley Archaeological Services Ltd

Site Code HSH07/71

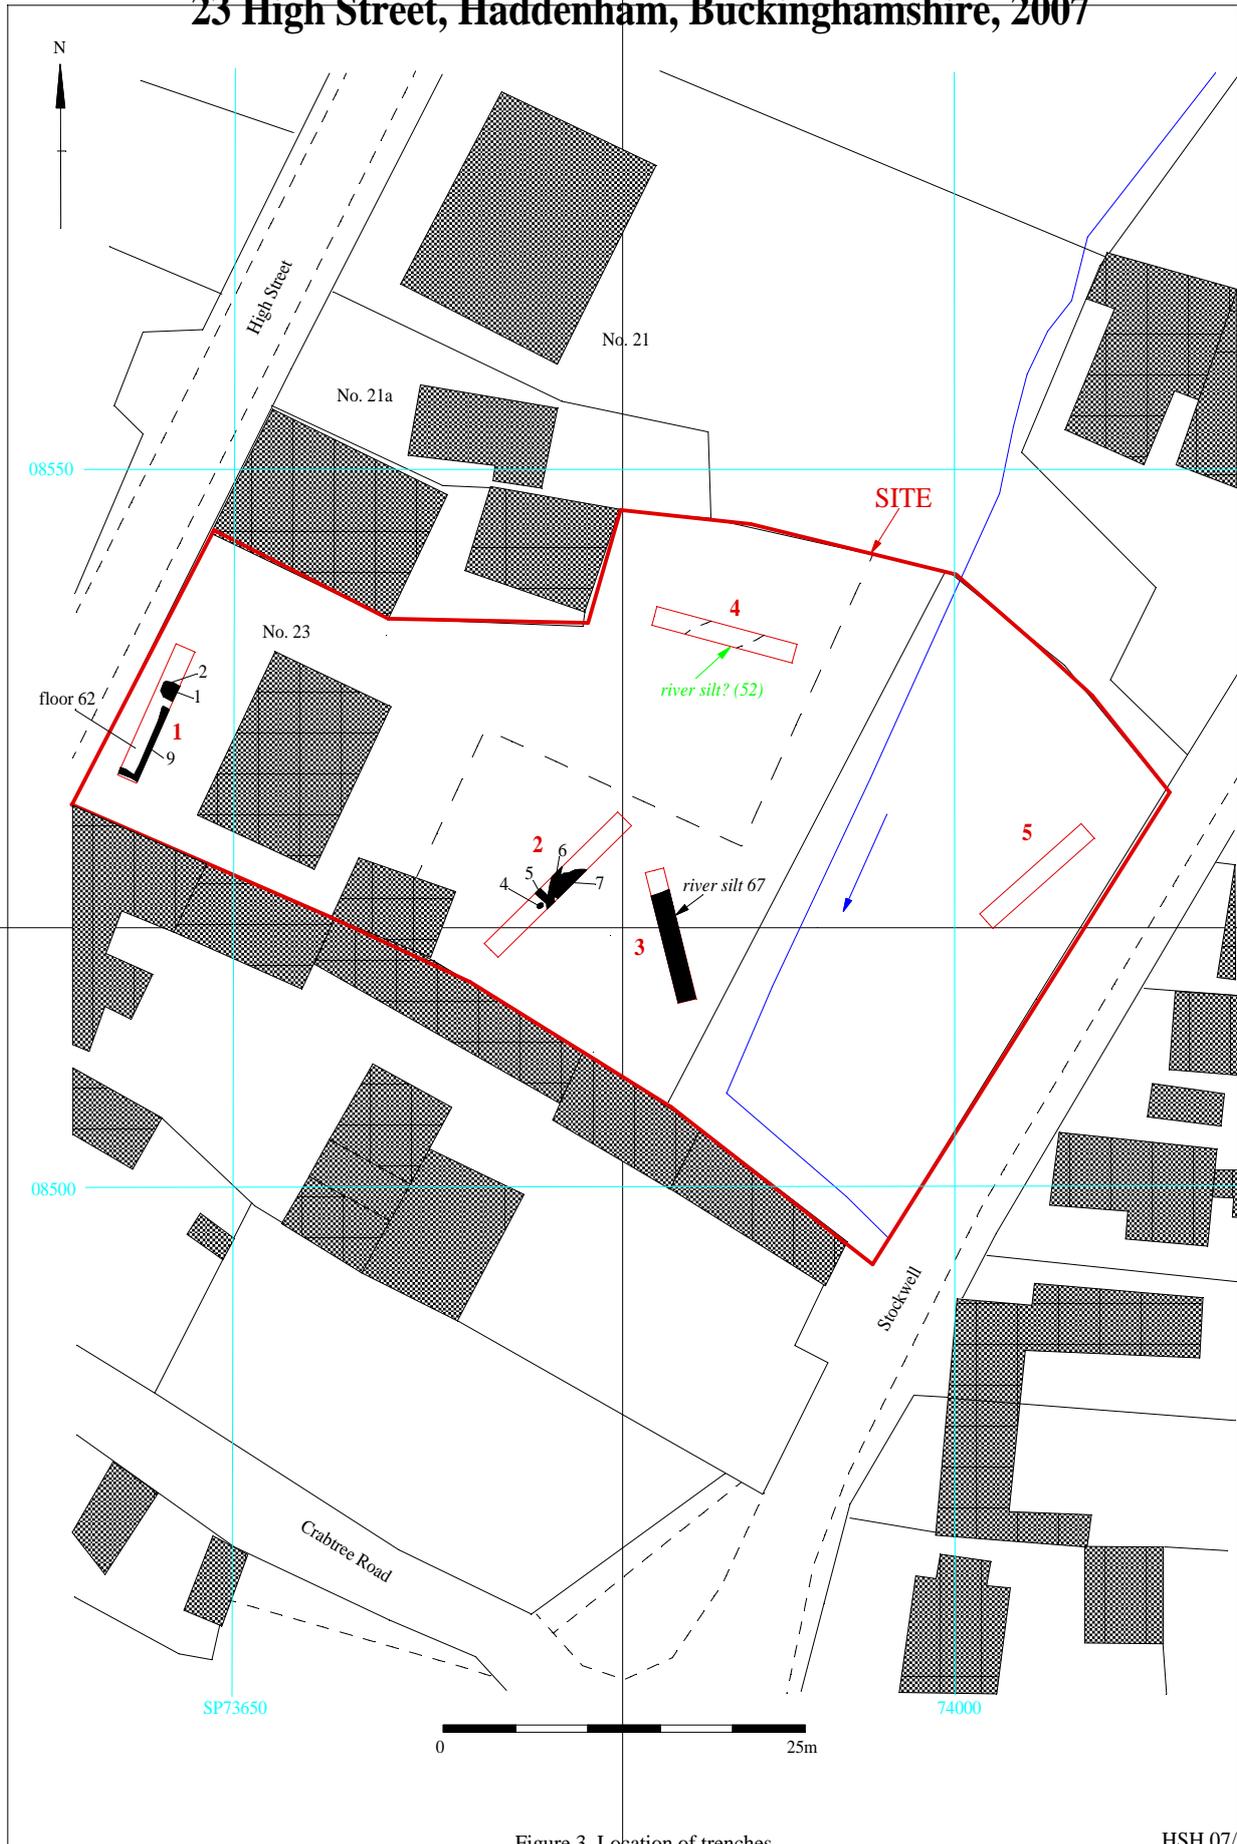
Figure 3. Location of trenches.

The five trenches were dug as intended though the position and orientation of Trench 5 was altered from the intended location due to the presence on site of mature trees and a large upstanding tree stump (Fig. 3). A list of trenches giving lengths, breadths, depths and a description of sections and geology is given in Appendix 1. A list of features is detailed in Appendix 2.

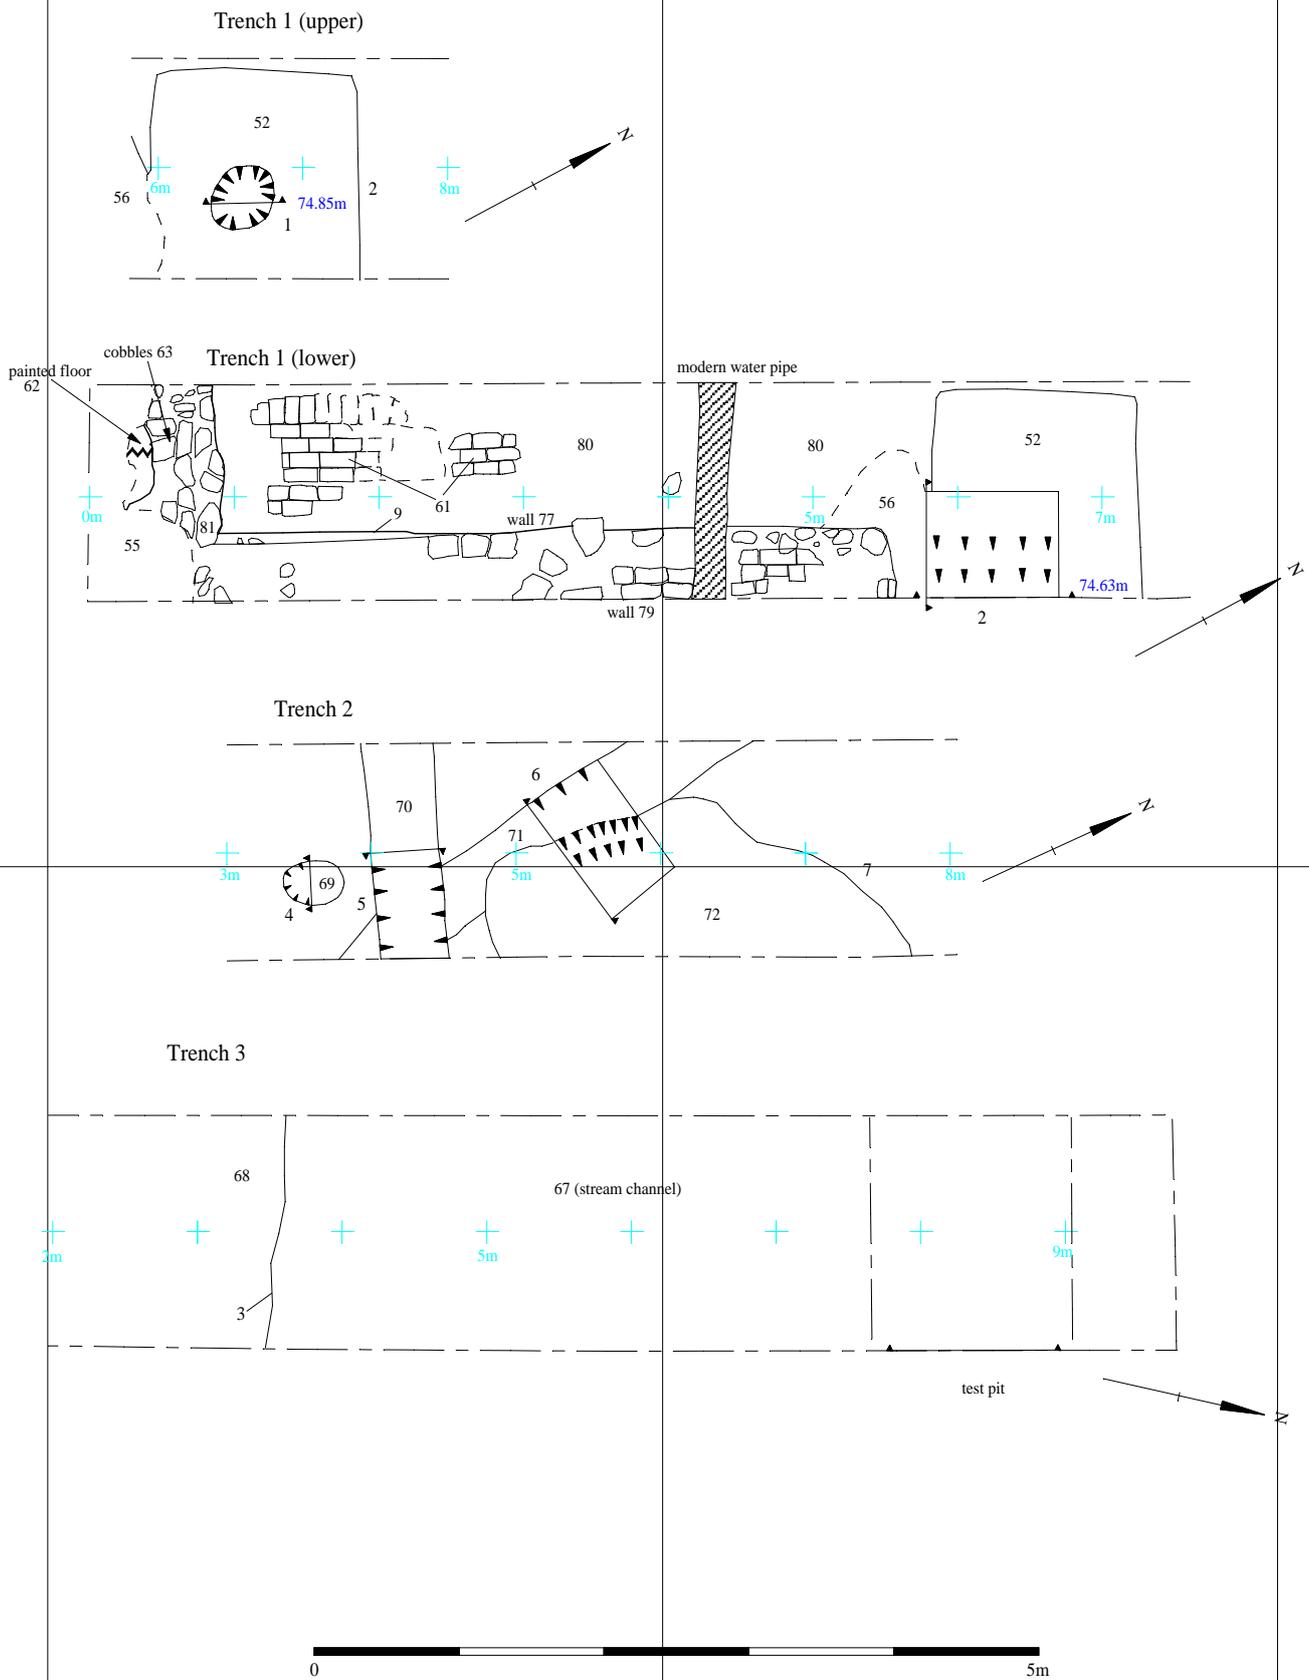
Figure 4. Detail of trenches.

Trench 1 was 10.10m long and mostly 0.26m deep in an area of Tarmac hard standing and was aligned SW-NE, parallel with the line of the High Street. A number of structural remains and features were recorded along its length (Fig. 4). These features and remains were at a very shallow depth. The stratigraphy comprised 0.05m of Tarmac over 0.09m of hardcore. Beneath the hardcore was layer 55, a mixed loose light yellow sand with mortar. This layer was up to 0.12m thick and extended across the whole trench. It contained frequent brick, tile (roof and floor), limestone and appears to be a demolition layer, or a levelling layer made up of demolition material.

Trench 2 was 10.10m long and up to 0.60m deep and was aligned NE-SW, in an area of lawn approximately parallel to the existing building. A number of features were observed within the trench (Fig. 4). The stratigraphy comprised topsoil 0.15m thick above a firm grey /black sandy silt with frequent limestone, flint, charcoal, brick and plastic fragments (66). It was 0.33m thick. Beneath this were four features cut into the natural head deposit.

Trench 3 was 9.60m long and up to 1.36m deep and was aligned SE–NW, in an area of lawn to the north of the stream. The stratigraphy comprised topsoil 0.14m thick above deposit 65, a yellowish brown sandy silt with very occasional flint fragments and charcoal flecks, 0.13m thick. It appeared to be a layer of redeposited subsoil. No artefacts were recovered from deposit 65. Beneath 65 was deposit 66 a firm grey/black sandy silt with frequent limestone fragments, flint fragments, moderate charcoal fragments, and occasional brick and tile fragments. It was 0.27m thick. One fragment of an iron nail was recovered from deposit 66. Beneath deposit 66 was a large feature (3) cut into the natural head deposits (Fig. 4).

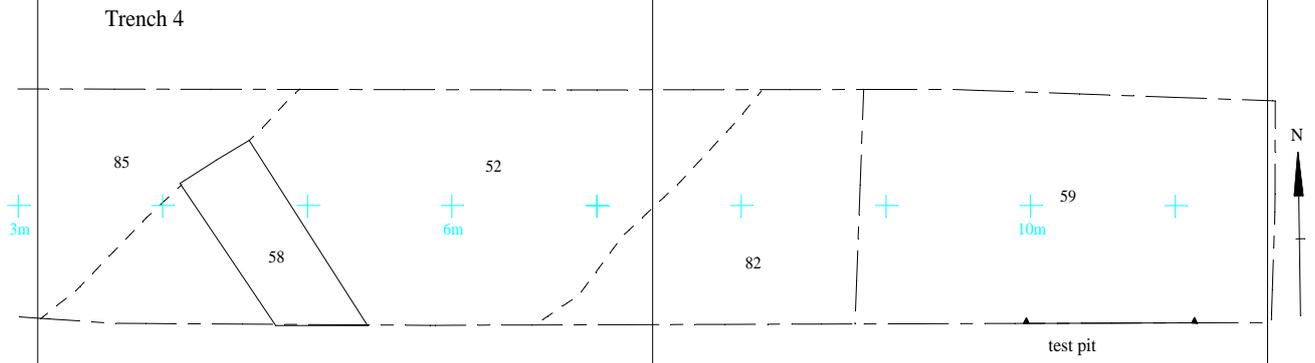
Figure 5. Detail of trenches.

Beneath these obviously modern layers was a sequence of deposits layers sloping from north to south along the trench (Figs 5 and 6). A hand dug section was excavated across these layers and a machine dug sondage was excavated at the southern end of the trench on the suggestion of the county archaeologist to examine the depth of the underlying natural. Five deposits were observed (57, 58, 83,84, 59). Layer 57 was a grey silty clay with limestone fragments and charcoal flecks and a lens of grey silty clay with mortar. It contained a sherd of 19th-century pottery. Beneath was layer 58, a firm greenish grey clay with occasional charcoal flecks but no artefacts. Beneath was layer 83 a greenish grey silty clay with very occasional charcoal flecks but again without artefacts. Beneath was layer 84. Layer 84 was very similar if not the same as the channel fill (67) in Trench 3, a dark grey clayey silt with very occasional limestone and chalk fragments. here were no visible artefacts. Finally beneath this was a green clay considered to be the natural geology. Layer 85 was beneath 58 in the northern end of the trench and was a mixture of limestone fragments and grey silty clay with very occasional visible charcoal flecks. It was not excavated and no artefacts were recovered from its surface. These layers are considered to be partially natural infill of the former stream channel.

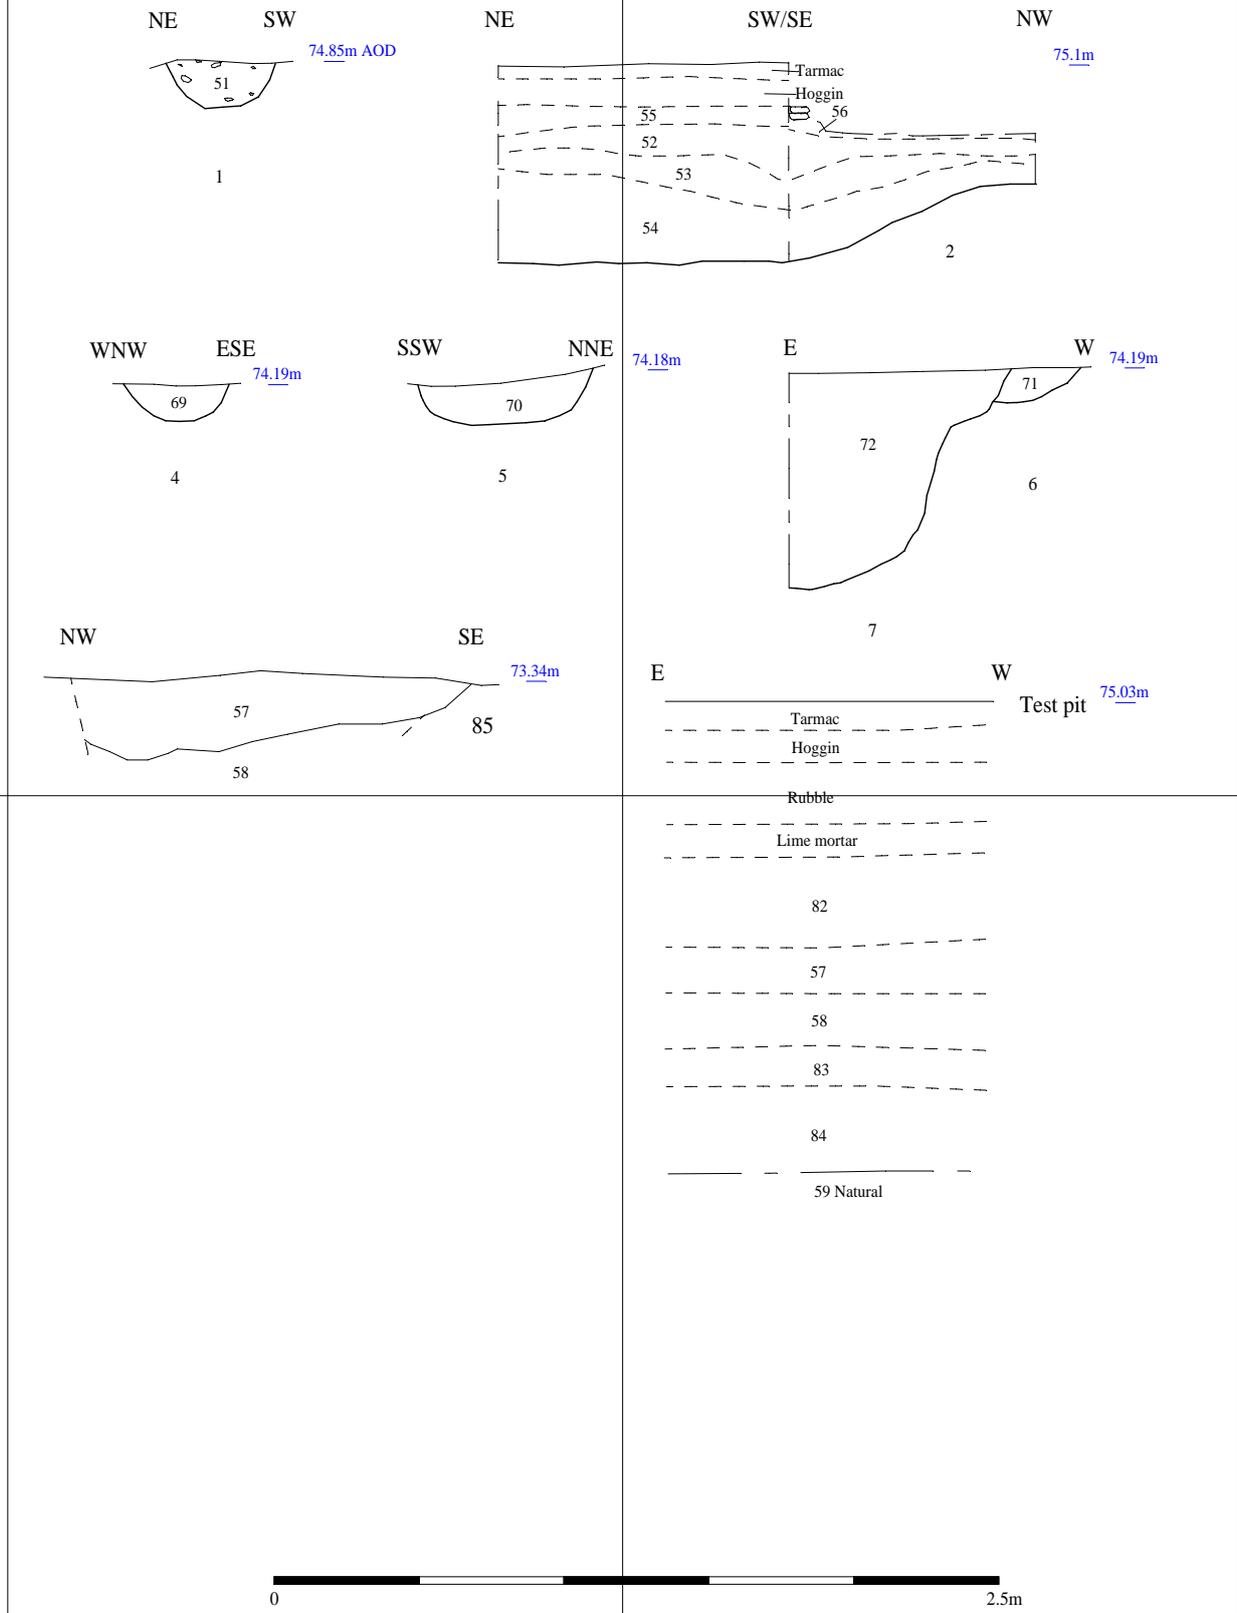
Figure 6. Sections.

Pit 2 appeared to cut through Building 1000 and a sondage was excavated within it to try to establish the stratigraphy of building 1000 and to find the depth of natural geology in Trench 1. On excavation it was established that pit 2 was, in fact overlain by deposit 56 (Fig. 6). The uppermost deposit within pit 2 (52) was a friable brownish grey sandy silt with occasional limestone fragments and very occasional charcoal flecks. Deposit 52 was 0.14m thick and contained 10 sherds of medieval pottery and one fragment of bone. Beneath deposit 52 was deposit 53, a greyish brown sandy clay with limestone fragments and very occasional charcoal flecks. Deposit 53 within the sondage was also up to 0.14m thick. It contained no artefacts. Beneath deposit 53 was deposit 54 which was a greyish brown sandy clay with limestone fragments increasing with depth and occasional charcoal flecks. Deposit 54 was 0.33m deep and contained 2 sherds of medieval pottery and 1 small piece of iron slag. Cut 2 as seen in the sondage had a flat base and was cut into natural limestone.

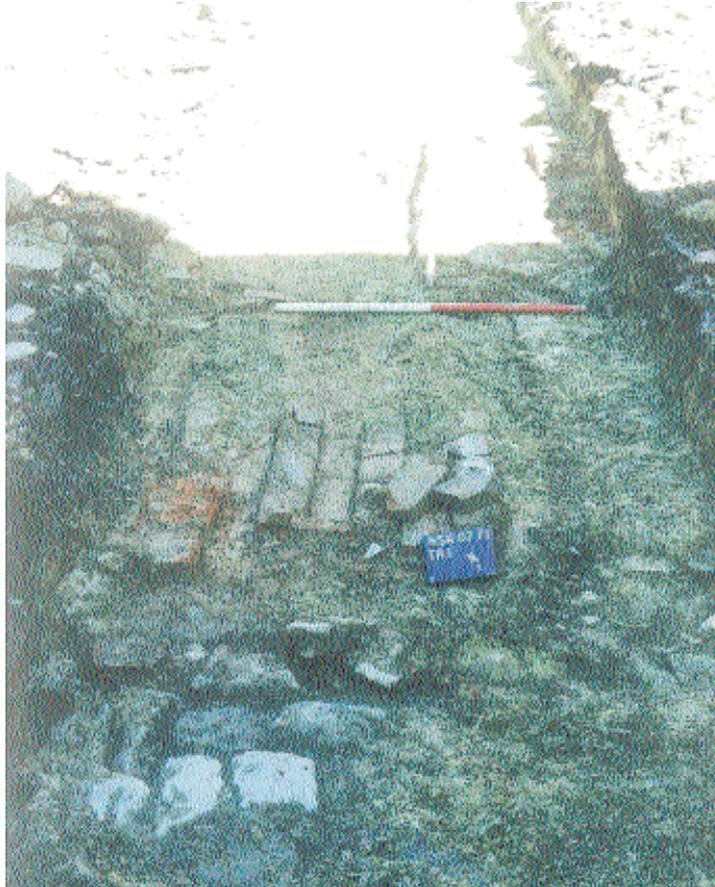
To the south of drain 63 was an area of painted brickwork 62. Only a small area of this brickwork was exposed at the south end of the trench. The brickwork appeared to be a floor that butted up to the edge of drain 63. An area of the painted floor was hand cleaned to revealed two areas of patterning. The first was a chevron or 'dog's tooth' pattern, the second area was made up of dots forming a geometric pattern. The remainder of the area was unpainted. The paint was in good overall condition and well preserved, but very fragile. Floor 62 extended southwards under the edge of trench 1.

Plate 1. Trench 1, floor 62, looking northeast; scales 2m and 1m.

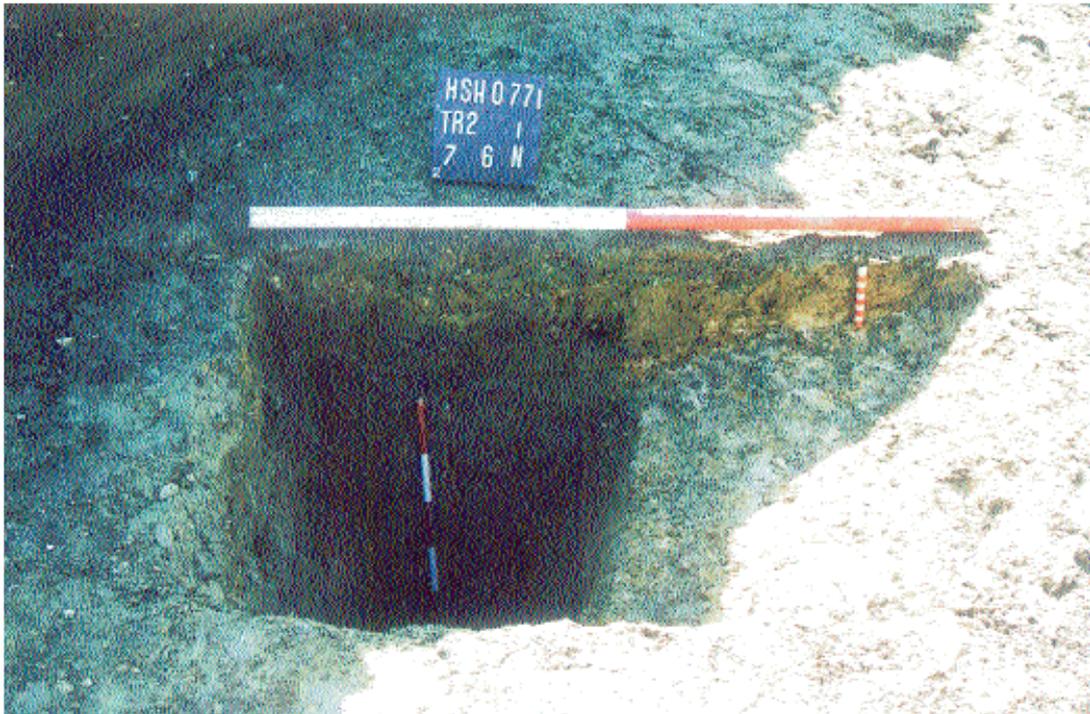
Gully 5 was filled with deposit 70, a firm greyish brown silty clay with very occasional flint fragments. It was 0.69m wide and 0.13m deep and contained two sherds of 18th-century pottery. Gully 5 cut gully 6. Gully 6 was 0.52m wide and 0.10m and cut the natural, a mid orange brown head deposit. It was filled with deposit 71, a firm brownish grey clayey silt with no inclusions. and no artefacts.

Pit 7 was filled by deposit 72, a firm mottled greenish grey silty sand with occasional orangey brown sand lenses, flint and limestone fragments. Two sherds of 18th- to 19th-century pottery was recovered. It was 2.85m long, 1.12m wide, 0.75m deep and cut gully 6.

Plate 2. Trench 2, linear 6 and pit 7, looking south; horizontal scales 1m, vertical scale 0.5 and 0.1m.
