# **The Former Officers' Residence, Priddy's Hard, Gosport, Hampshire**

**An Archaeological Evaluation  
for Crest Nicholson (South) Ltd**

Site Code PHG04/20

**May 2004**

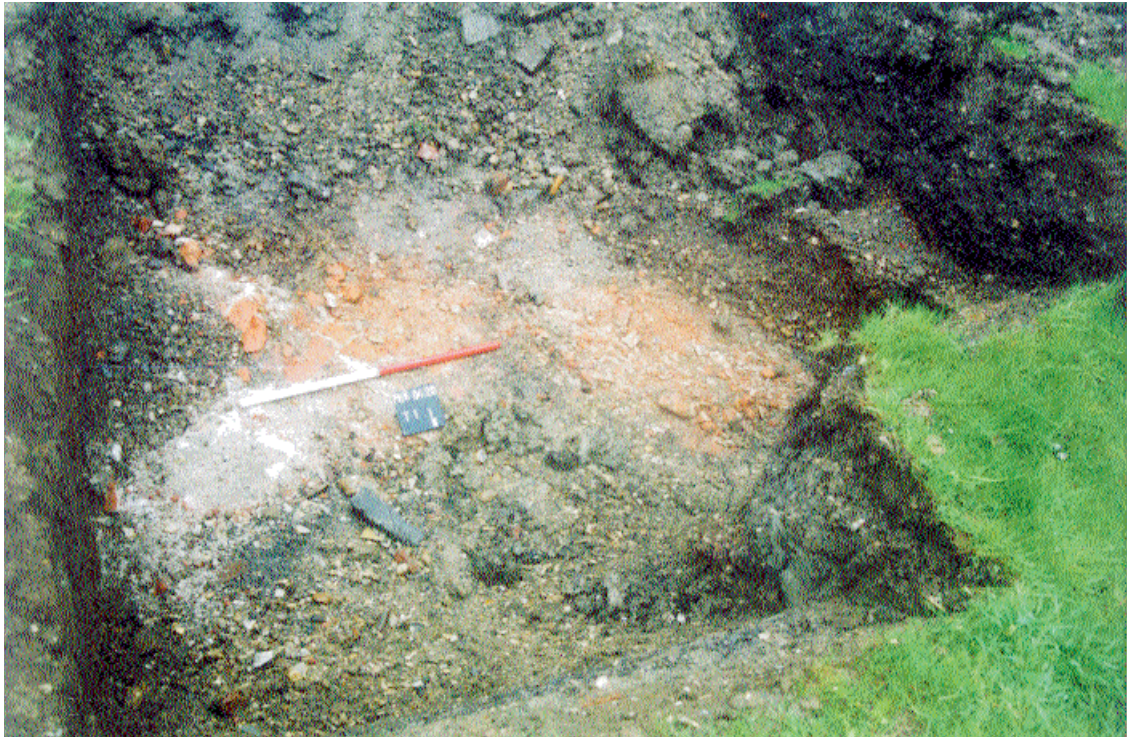
Plate 1. Trench 1 looking south, showing the front west window opening. The trowel marks the western corner of the building, 1m scale.

This trench was dug to locate the western corner of the front of the demolished building. One of the brick window openings was exposed in the bottom of the trench, still intact, however the corner of the building only survived as a robber trench filled with demolition rubble. The top of the surviving footings was reached at approximately 2.85m AOD, with 0.42m depth of footing surviving before natural gravel was reached. The bottom of the footing was at approximately 2.45m AOD.

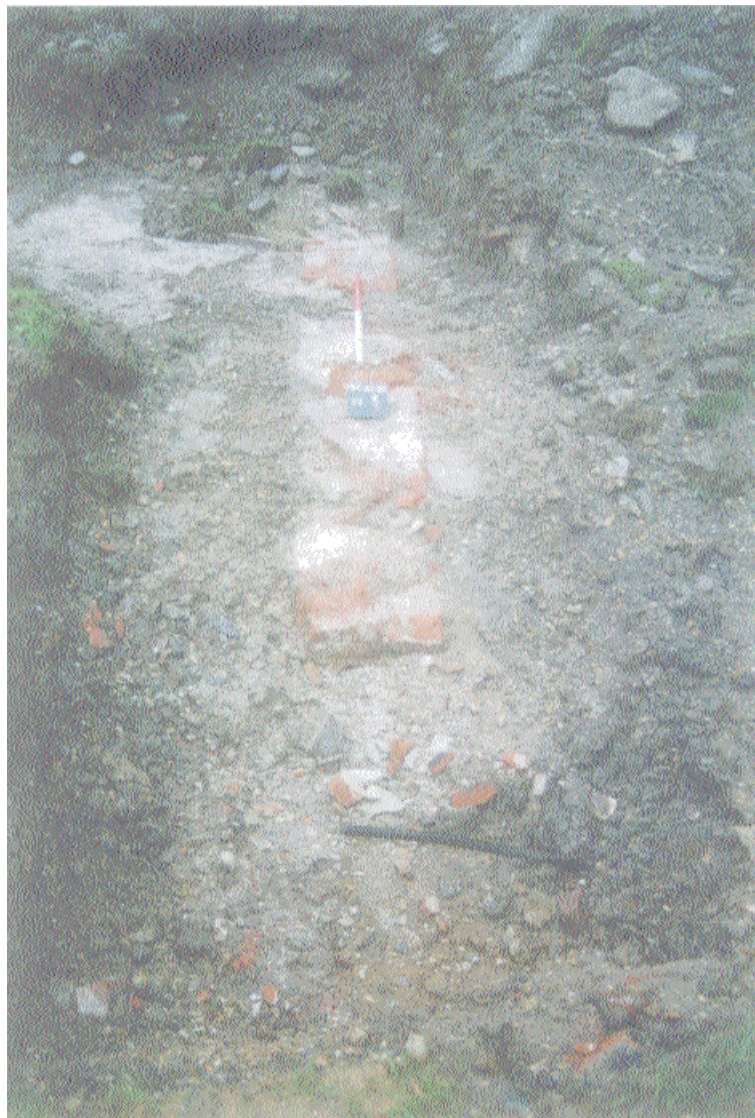
Plate 2. Trench 4 looking north, showing the rear eastern corner of the building and surviving wall, 1m scale.

This trench was dug in an L-shape to determine where the edge of the rear eastern corner of the building had stood. A stretch of the footing of the eastern wall of the building survived for approximately 2m in length and it was possible to determine where the corner of the building had been. Immediately adjacent to the surviving footing had been a cellar and staircase which were infilled with rubble. A robber trench was located indicating a demolished wall forming the other side of the eastern rear wing of the rectangular plan.

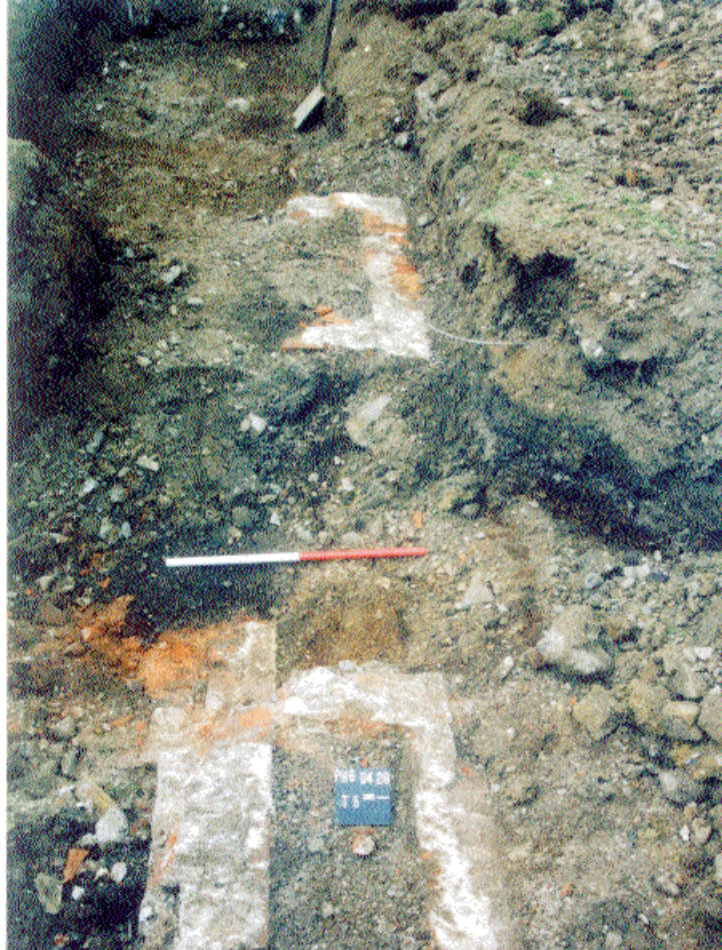
**Plate 3. Trench 5 looking east, showing the surviving front eastern window openings. The shovel marks the front eastern corner of the building, 1m scale.**

This trench located the two front brick window openings on the eastern side of the house. They survived intact, however any connecting walls were completely destroyed, including the corner of the building which was extrapolated from the robber trench.
